Condition Assessment of Unbonded Post-Tensioning Strands

A case study using nondestructive testing to evaluate the floor slab of a parking structure

BY SUNIL PURI AND DANIEL E. MOSER

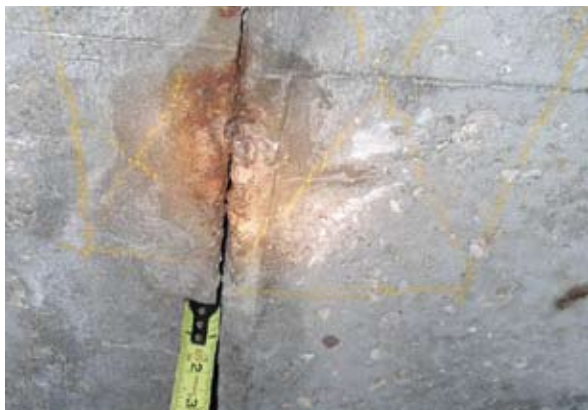
The condition of the construction joint between Grid Lines 6 and 7 also provided preliminary clues about the condition of the embedded post-tensioning. Although the upper slab surfaces were at the same elevation on each side of the construction joint, we noted that the slab soffits were not vertically aligned (Fig. 2). We surmised that the vertical offset was not the as-built condition. Rather, it seemed that one side of the slab had deflected over time, and the upper surface had been patched to maintain a smooth riding surface (Fig. 3). To confirm this hypothesis and identify probable causes for the differential deflection, we undertook a thorough condition assessment using NDT evaluation of the post-tensioning strands and intermediate anchorages at the construction joint.

Fig. 2: Differential in the elevation of the bottom of the slab at the construction joint

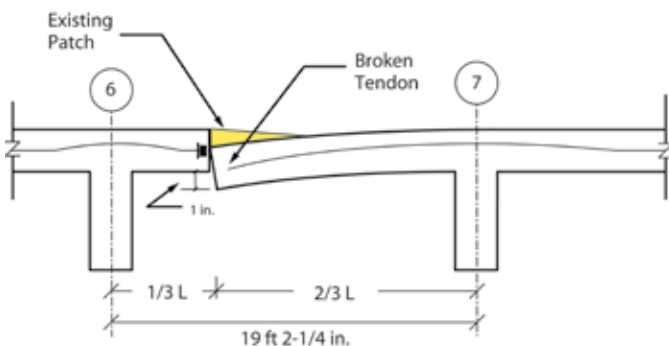
Fig. 3: Illustration depicting the differential in the elevation of the bottom of the slab

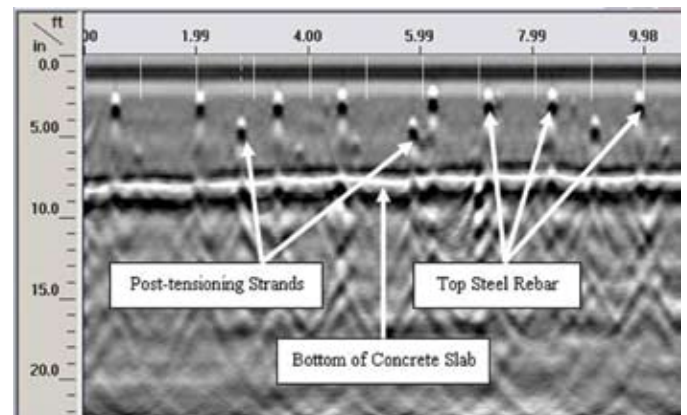
A 1.5 GHz nominal frequency antenna was used, and multiple scans were performed to locate embedded strands and search for breakages. Figure 4 presents results from a typical GPR scan, showing embedded strands along with steel reinforcing bars. GPR data indicated that post-tensioning strands were spaced at about 2 ft (0.6 m). Our analysis of the GPR data indicated that 4 of the 24 located strands were severed (Table 1).

Fig. 4: Typical GPR scan showing embedded strands and reinforcing bars

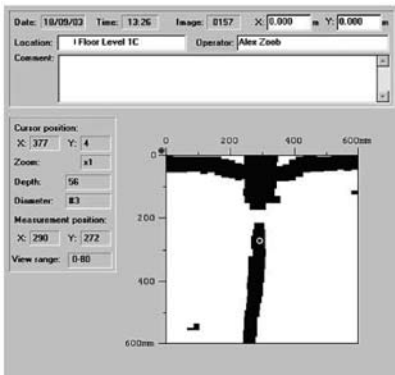
Eleven randomly selected strand locations were scanned. The results indicated eight severed strands (Table 1). The analysis of the magnetic scans also indicated that the strands near the breaks were on average 2.1 in. (56 mm) below the surface. A typical image of a severed strand, with a gap between the strand

Fig. 5: Magnetic scanning image for a typical severed strand

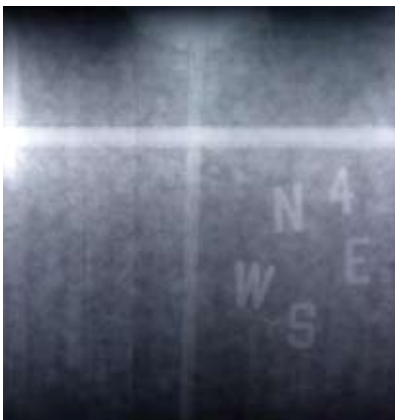
When used to evaluate concrete structures, x-ray radiography provides two-dimensional images of embedded, high-density materials such as steel. A radiograph of an intact strand along with the embedded intermediate anchorage and a reinforcing bar is shown in Fig. 6. The high-density material is shown on the radiograph as a white zone, while the concrete appears as a dark area.

Fig. 6: X-ray radiograph for Strand 4

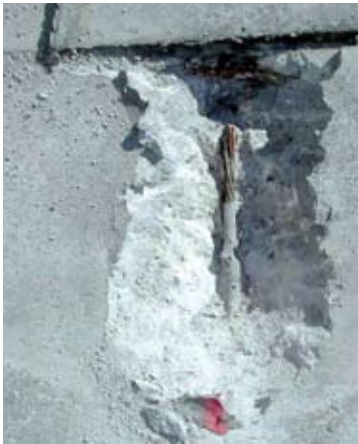
The exploratory openings confirmed the results of the magnetic scanning and x-ray radiography. Comparison of the photo of the severed strand in Fig. 7 with the magnetic scan image in Fig. 5 shows that the instrument accurately depicted the existing condition of the severed strand.

Fig. 7: Severed strand revealed after exploratory opening was made (magnetic scanning image of the same strand is shown in Fig. 5)

Exploratory openings also revealed that, while the strands were covered with plastic sheathing along the majority of their length, they were not protected by sheathing near the intermediate anchorages (Fig. 7). Unprotected sections of strand about 4 to 5 in. (100 to 125 mm) long were likely exposed to chloride ions from deicing chemicals. Most of the strands had lost a significant percentage of their cross section at this location. ACI 423.4R-98, “Corrosion and Repair of Unbonded Single Strand Tendons,”² notes that it was common practice to stop the sheathing short of the anchorages at the time of the original construction of the parking structure.

With such a high percentage of severed strands and strands with significantly reduced cross sections, the load carrying capacity of the floor slab was considerably reduced. Per our recommendation, the floor slab was shored and repairs were made to the post-tensioning system and concrete.
