WHAT EVERY  
PARKING GARAGE  
OWNER NEEDS TO KNOW

# HOW TO USE THIS GUIDE

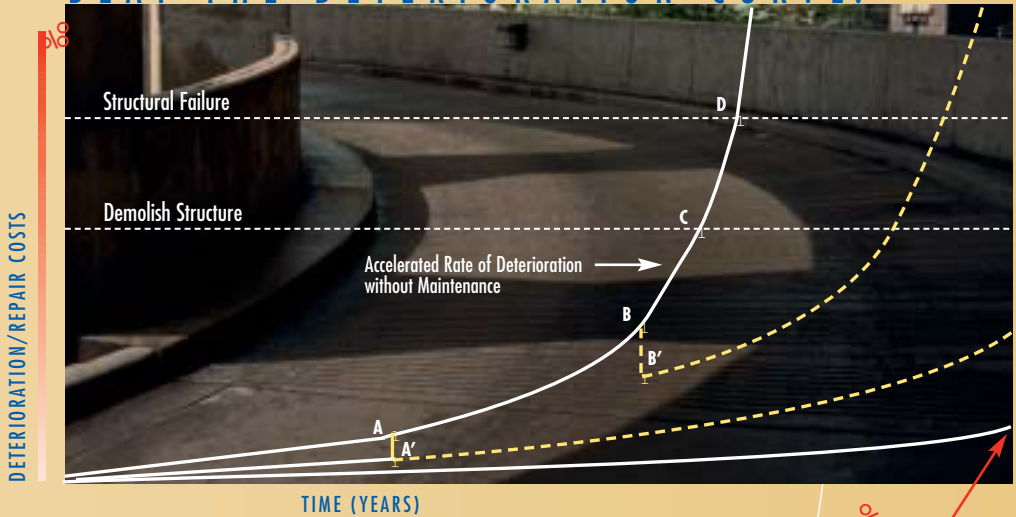
# BEAT THE DETERIORATION CURVE.

1. Points A-D represent stages of accelerated deterioration in parking structures.
2. Structures repaired at point A cost less overall and last longer than structures repaired at point B. Compare curve A' to B'.

**E**ach year, parking structure owners and operators all over the country face major unwanted “surprises” in their parking structures. Either through lack of knowledge, awareness, or budget, their parking structures have deteriorated to the point of needing major repairs. Repairs that cost a great deal. Repairs that, in many cases, would not have been necessary if the parking structure had been properly maintained on a regular basis since it was put into service.

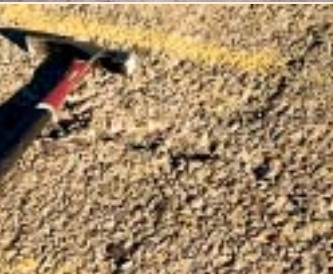
### *cracking*

Typical Repair Cost:  
\$40,000\*

Concrete cracking is caused by stress. This stress is either construction or service related. Cracking commonly attributed to construction is caused by improper concrete placement, consolidation, and/or curing; premature removal of forms; or by plastic shrinkage of the concrete. Service related cracking is usually due to the temperature changes, load, settlement, or internal stresses. Corrosion of reinforcement and aggregate chemical reaction are common causes of internal stress.

Not all cracking is detrimental to the concrete member. In many cases, cracks are anticipated and reinforcement is provided to transfer stress across the cracks. Properly positioned reinforcement arrests crack development by keeping cracks short and tightly closed. Cracking can be detrimental when it occurs to an extent and with a frequency not expected. If this happens, steps are necessary to minimize the effect cracking has on long-term structure durability.

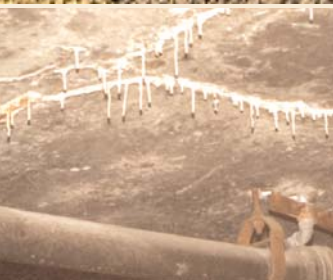
### *scaling*

Typical Repair Cost:  
\$25,000\*

Scaling is characterized by progressive deterioration of the concrete surface through paste (sand/cement) failure. It results from the disruptive forces generated in the paste when the concrete freezes. Scaling is common in those areas of the continent subject to freeze/thaw cycling.

Scaling begins with a slight surface flaking, which becomes deeper with continuing exposure. Initially, only the surface texture and small amounts of paste are eroded. Eventually, however, coarse aggregate is exposed, and larger surface areas are affected. Scaling can significantly impair the serviceability of concrete intended as driving or walking surfaces.
