Condition Assessment of Unbonded Post-Tensioning Strands

A case study using nondestructive testing to evaluate the floor slab of a parking structure

BY SUNIL PURI AND DANIEL E. MOSER

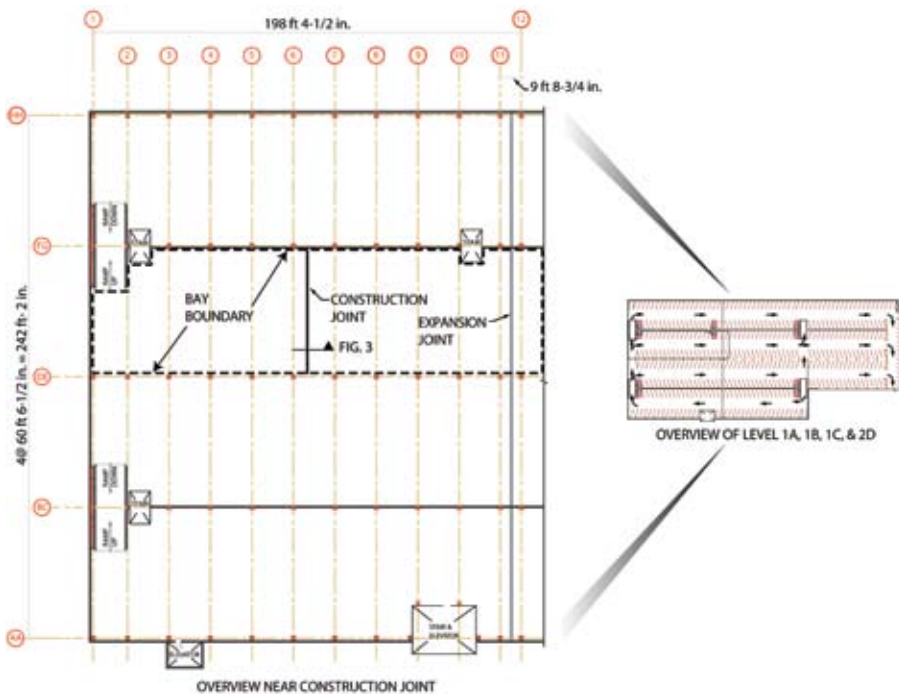
Fig. 1: Plan of the parking garage showing the area of the post-tensioned floor slab that was investigated with various NDT techniques
